Cracks Failed To Alarm Bridge Team

The morning of the collapse, the engineer of record assured the project team that the FIU pedestrian span was safe

NTSB: Errors By FIGG Led To Collapse

Final NTSB Collapse Report Details Bridge Team Failures

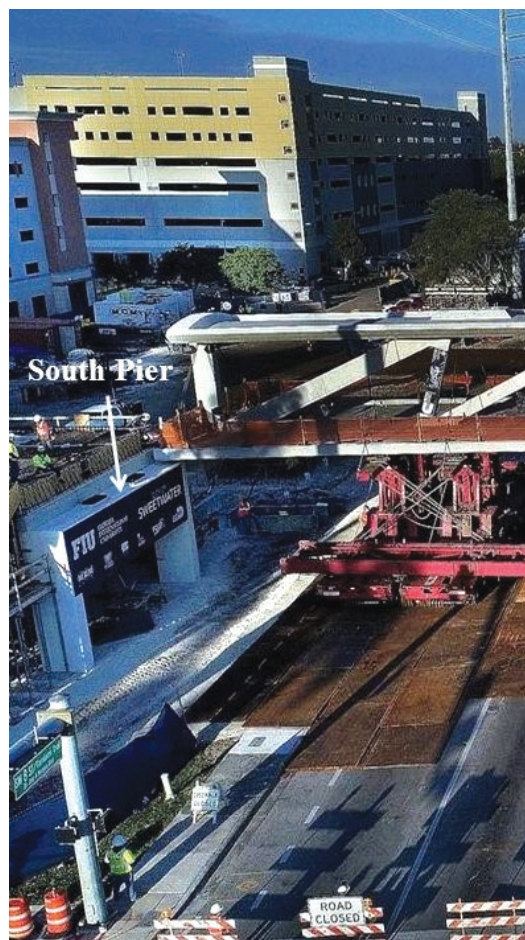
Then, on March 15, 2018, engineers, contractors, consultants, state DOT representatives and officials with FIU, the project owner, gathered to hear why the bridge designer thought cracks were occurring. The section in question was the

ONGOING INVESTIGATION The National Transportation Safety Board identifies on this photo key elements of the bridge.

bottom chord of the concrete truss comprising the bridge, at one of the diagonal web members at the structure's north end.

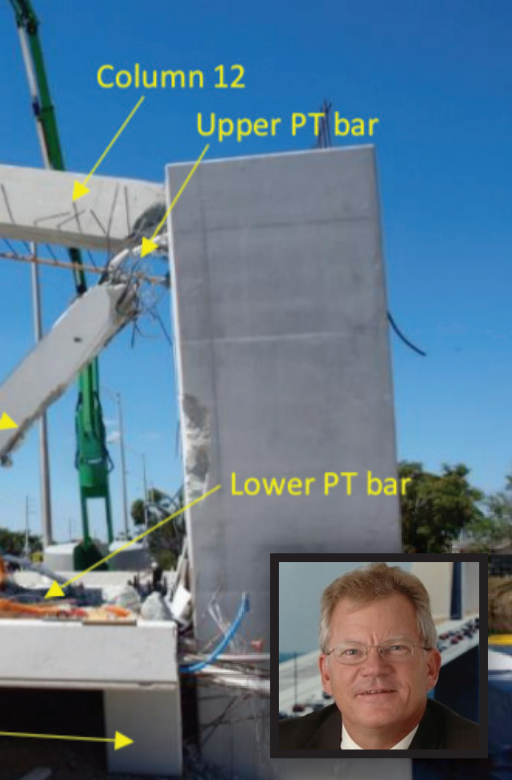
CRITICAL NODE Engineer Denney Pate stamped plans for pedestrian bridge where report claims key node at diagonal 11 was underdesigned.

OSHA found key errors in the design that opened the door to failure prior to completion. The report alleges that FIGG underdesigned a key diagonal member of the truss's web, 11, and its connection to other structural components. OSHA criticized FIGG's use of a non-redundant design and claimed the company failed to assess the risk from widening cracks just prior to collapse.

Instead, two days before the collapse, FIGG recommended placement of a shim under the bridge diaphragm and retensioning of post-tensioning bars in diagonal 11. During the retensioning, the concrete blew out at the junction of diagonal 11 and 12, and the structure thereafter failed progressively. An employee of VSL, MCM's post-tensioning subcontractor, Navarro Brown, suffered fatal injuries as hundreds of tons of concrete and steel fell onto the road.

"The [engineer of record] should have immediately instructed that the bridge be shored at appropriate locations and SW 8th Street be closed," wrote Ayub.

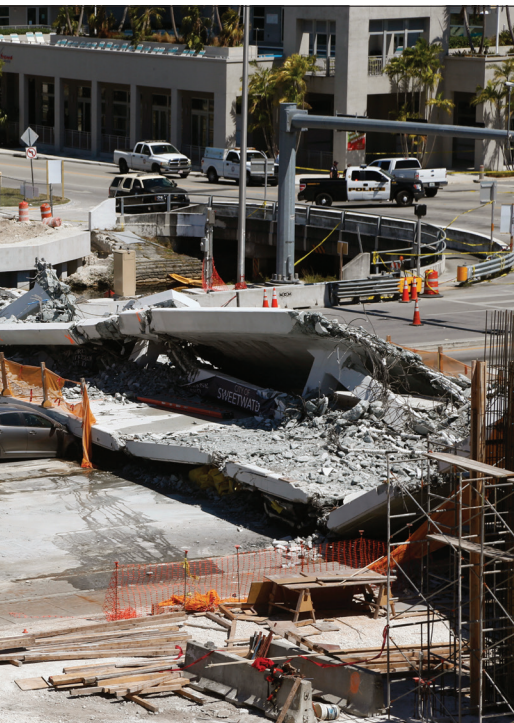
TRAGIC RESULT The March 15, 2018, collapse killed six people, including one project worker and five motorists.

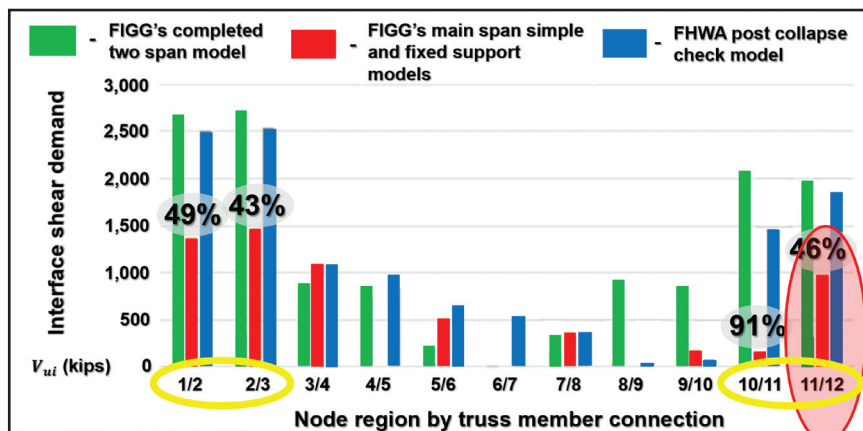
Walsh noted in the report that FIGG performed four demand models. Just one of those models estimated demand consistent with FHWA’s findings, however. Critically, FIGG used the other models, which estimated demand to be between 43% and 91% lower than FHWA’s estimates had calculated. ■

FAULTY DEMAND ESTIMATES? An NTSB report on bridge design errors noted that the demand model FIGG used underestimated the demand that the structure would experience.

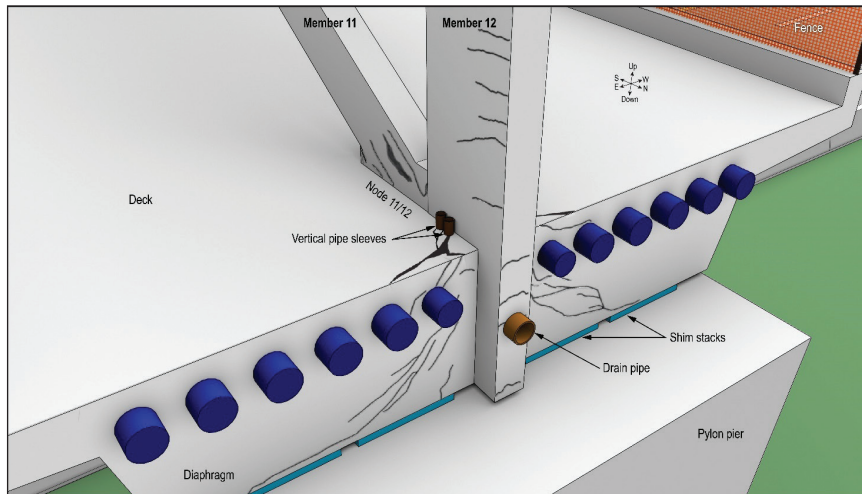
CRACKS BEFORE COLLAPSE This image from the NTSB's final report shows a south and east view of the extent of cracking at member 11/12 nodal region, deck and diaphragm, indicating structural distress.

To this, the NTSB report replies: "The retensioning of member 11 on March 15 was the final stressing force that resulted in the failure of the member 11/12 nodal region."
