OROVILLE OVERHAU

BEATING THE CLOCK

Engineers and workers at Lake Oroville race to complete critical spillway repairs to mitigate catastrophic flood risk for downstream communities. By Scott Blair in Oroville, Calif.

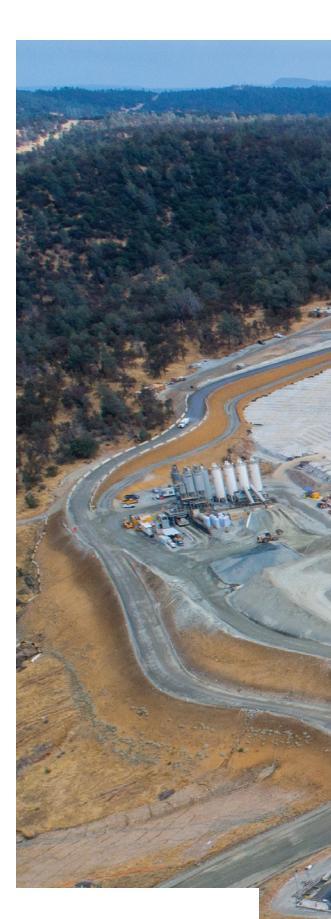
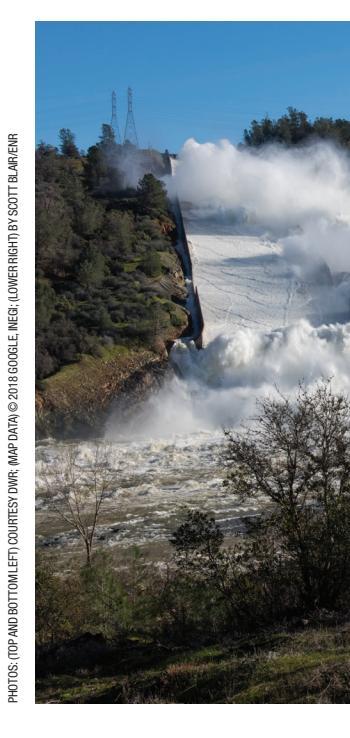
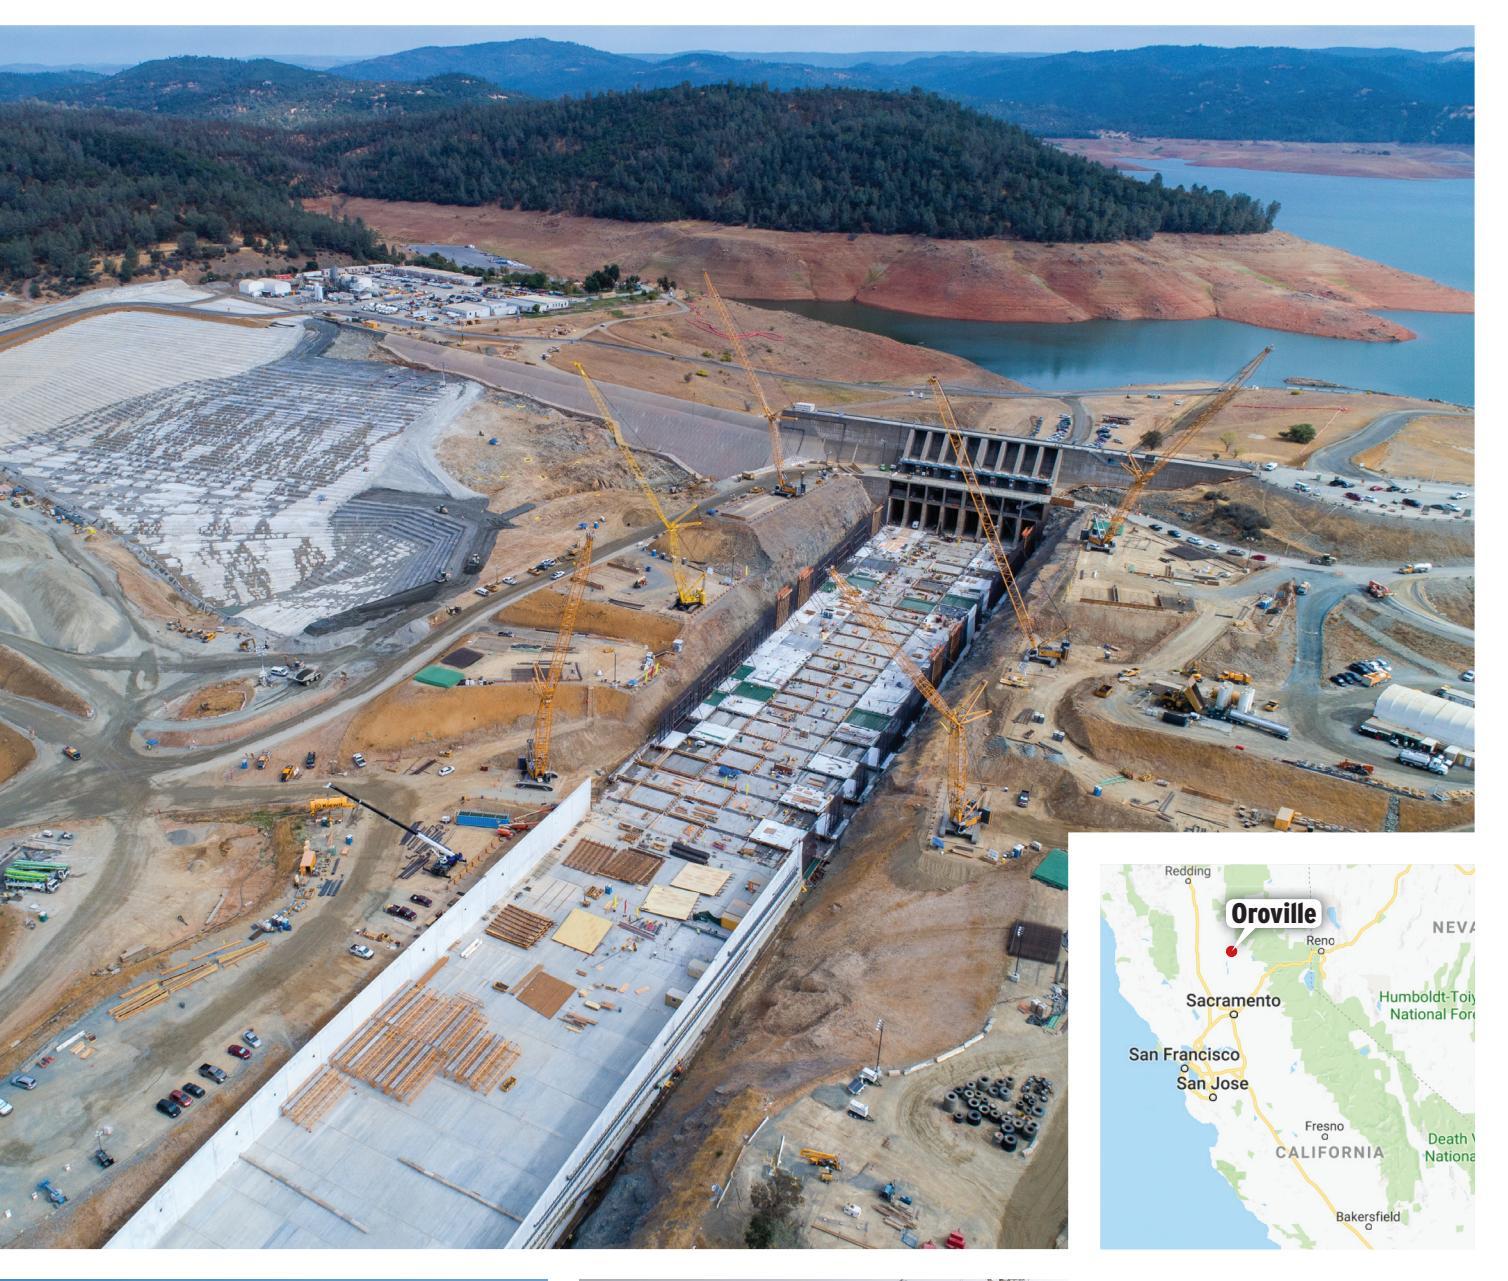
BIG FOOTPRINT

After record rainfall in winter/spring 2017, water released from Oroville Dam tore through the main spillway chute and hillside (below). Repairs include a new splash pad apron (upper left of top photo) below the emergency spillway and a more robust concrete main spillway (right). Crews place structural erosion-control concrete (bottom right).

To prevent overtopping, DWR again released water down the main spillway. While this averted the disastrous erosion of the emergency spillway and surrounding hillside and allowed residents to return home, the releases continued to erode the main spillway, eventually leaving a 1,100-ft-long, 200-ft-deep scar in the spillway and adjacent hillside.

The main spillway work was divided into two phases because no construction could occur during the winter rainy season from December until May. Phase one, completed November 2017 (ENR 12/11-18, 2017 p. 10), rebuilt two sections of reinforced structural erosion-control concrete in an 870-ft-long upper chute section and a 350-ft-long lower section. Crews also placed some 350,000 cu yd of roller-compacted concrete (RCC) to fill the massive gouge and to create a temporary spillway surface and walls. The relatively undamaged portion of the old spillway just below the gates remained in place for the season.

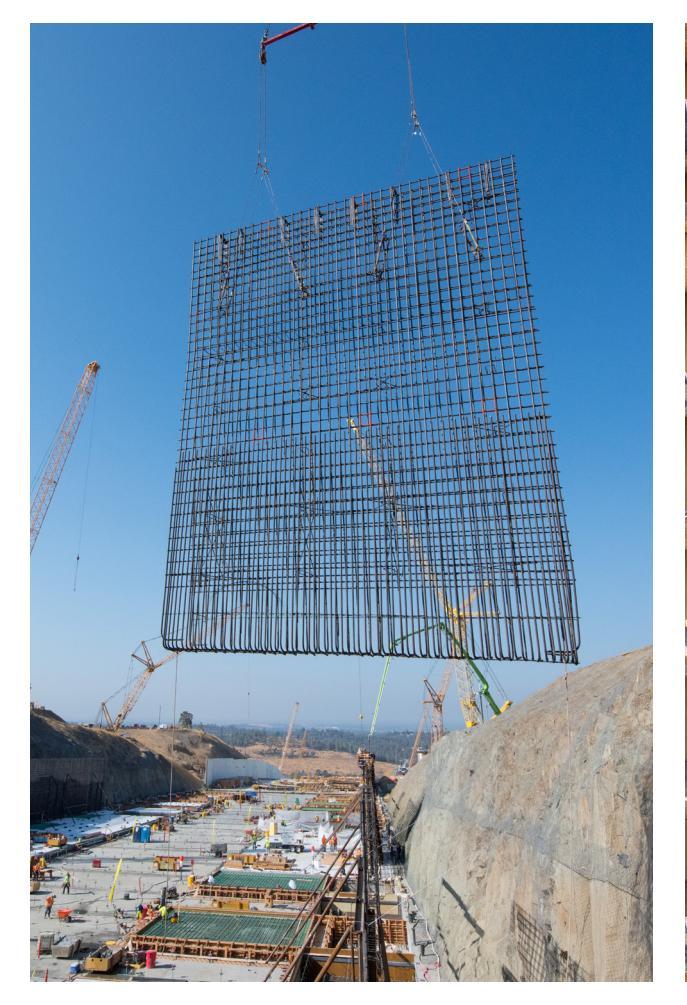
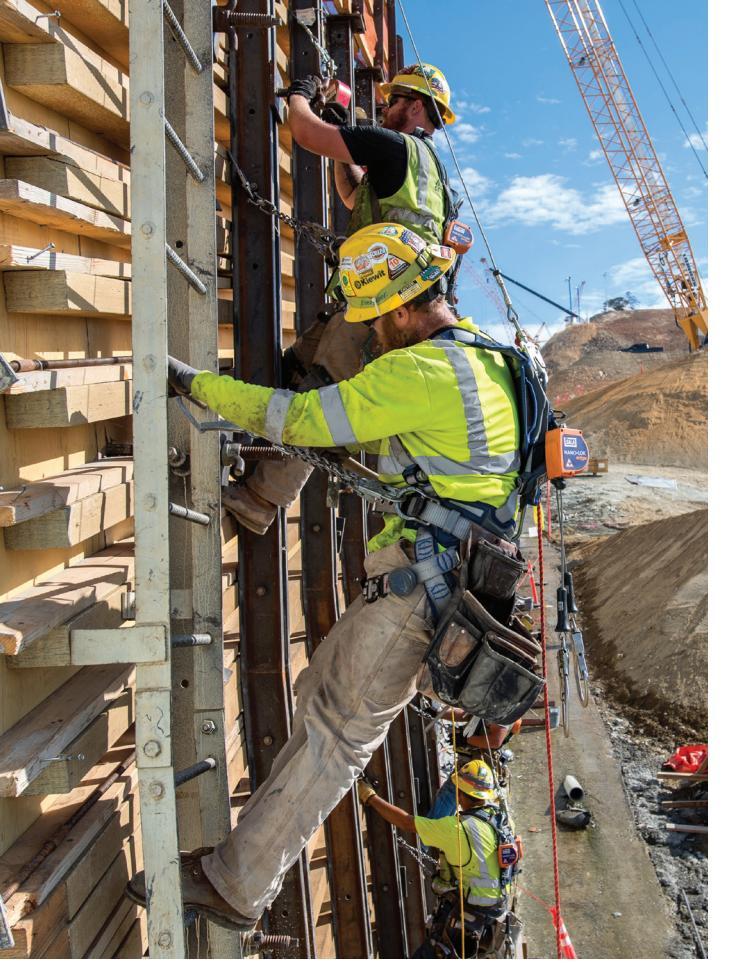
FORM FUNCTION One of twelve lattice cranes flies a pre-assembled rebar cage for a section of spillway chute wall into place (left). Once the cage is tied into place, workers install formwork and ready it for concrete (middle).

"To accelerate the schedule, we pre-tie the wall cages out on grade beside the spillway and then we fly them in and tie them in place," Petersen says. This allows crews to form the cage while the bottom slab is still curing. "It takes a little extra steel and a template to hold the wall cage up, but the time savings way offsets the cost of doing the extra rebar."

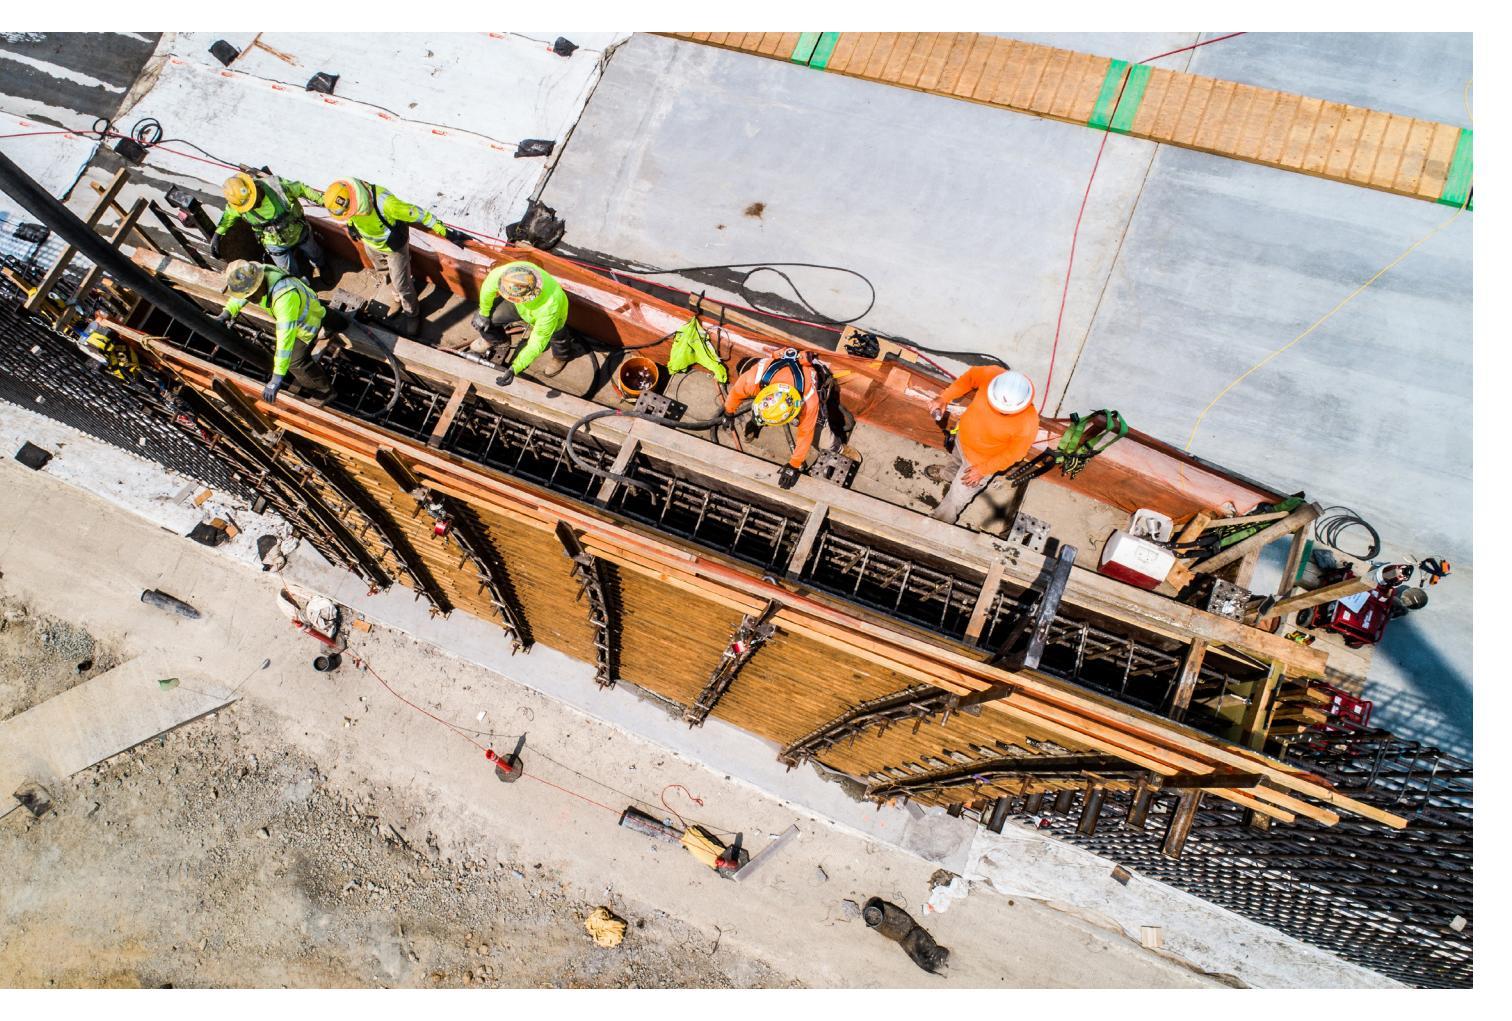
TOP DOWN

Crews work from atop the 20- to 34.5-ft-tall wallforms to place concrete on a spillway chute wall segment. The team will place 126 wall sections this season alone. the curing process and reduce the minor surface cracking that occurred on some of last year's slabs, he adds.

Last season, concrete finishing crews found that pulling a screed up a 25% slope by hand was slow, expensive and exhausting. This season, engineers fabricated a homegrown solution, nicknamed "Franken-screed" because it's an assemblage of disparate parts. A carrier beam holds the 37-ft-wide screed, which is then pulled up-slope using portable electric winches mounted on the frame. While similar equipment is commonly used for leveling concrete on flat ground, Franken-screed's modifications for use on the steep grade and its portability via crane make the apparatus one of a kind, Petersen says. Wall sections run along each side of the 178.5-ft-wide spillway and range from 20 ft to 34.5 ft in height. They vary in width from 2 ft at the top to about 5 ft at the base.

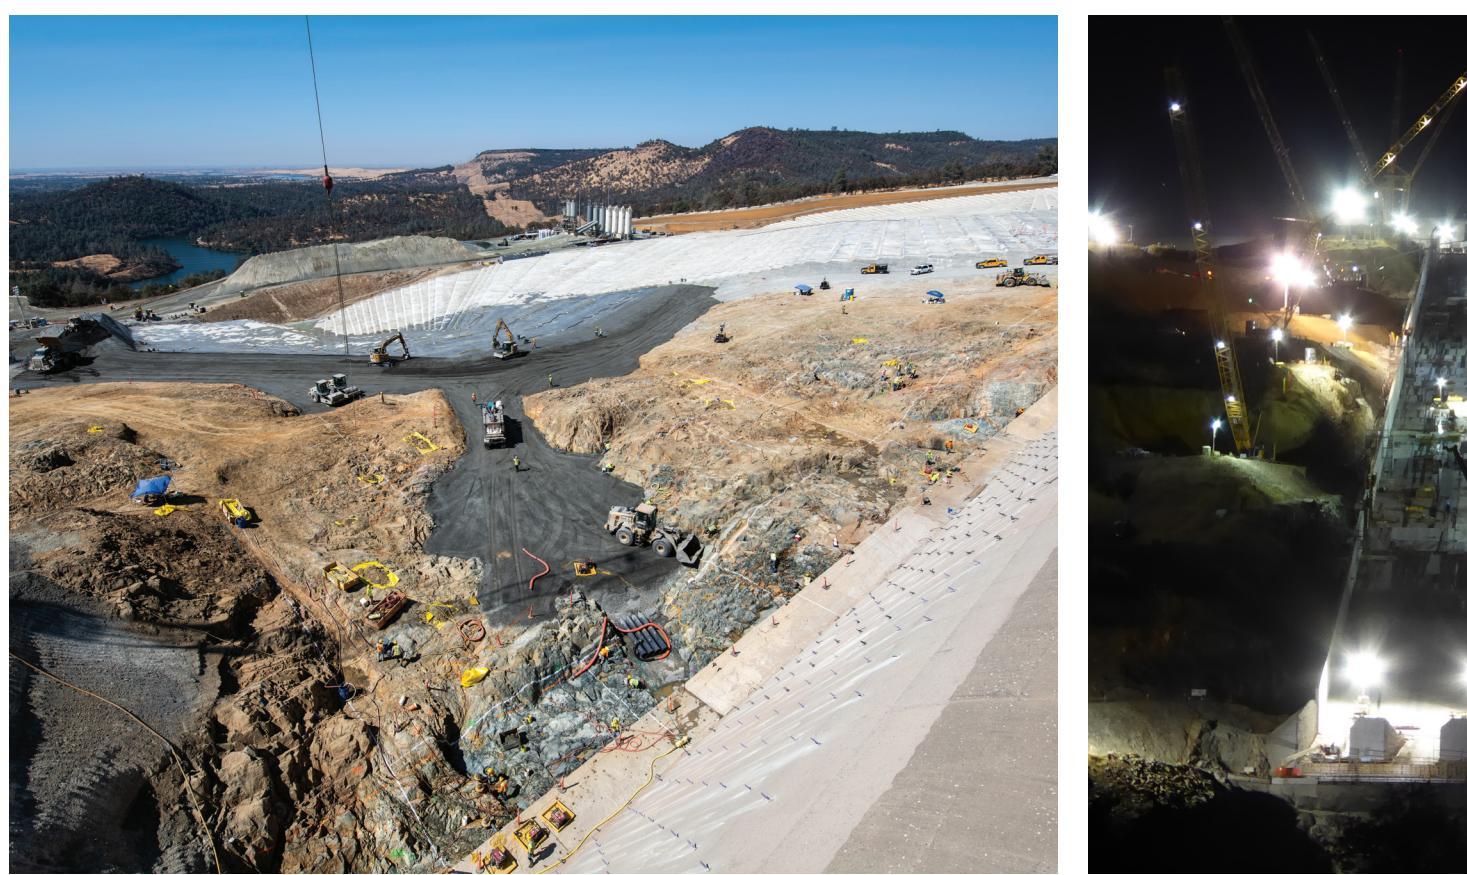
GO WITH THE ROLL Workers lay rollercompacted concrete in layers to create an energy-dissipating stairstep pattern on the emergency spillway splash pad apron.

When work on the main spillway paused during last winter's rainy season, the project team focused on repairing and bolstering the emergency spillway. Crews embedded a 1,450-ft-long secant-pile wall into bedrock at depths between 35 ft and 65 ft. The wall will prevent the headcutting erosion that occurred in February 2017, DWR designers say. Currently, operations are running full tilt to complete a 1,830-ft-long by 750-ft-wide splash pad apron, incorporating more than 700,000 cu yd of RCC. The apron's stair-step pattern will help dissipate the energy of any water released over the emergency spillway.

The RCC's finish also acts as an energy dissipater, says Phil Kelley, RCC superintendent. The RCC is placed in 1-ft increments, and excavators use GPS to stay on the correct grade. Kiewit "fabricated a special plate on another [excavator] to act as a trowel to give us this finish, which is a newer innovation that we were able to come up with," he adds.

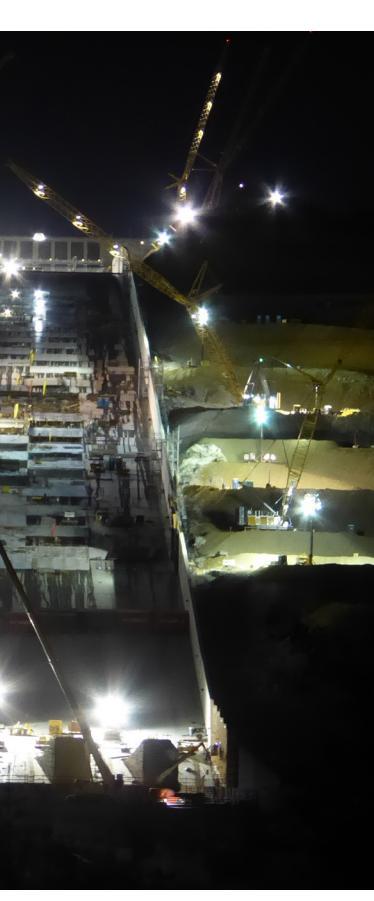
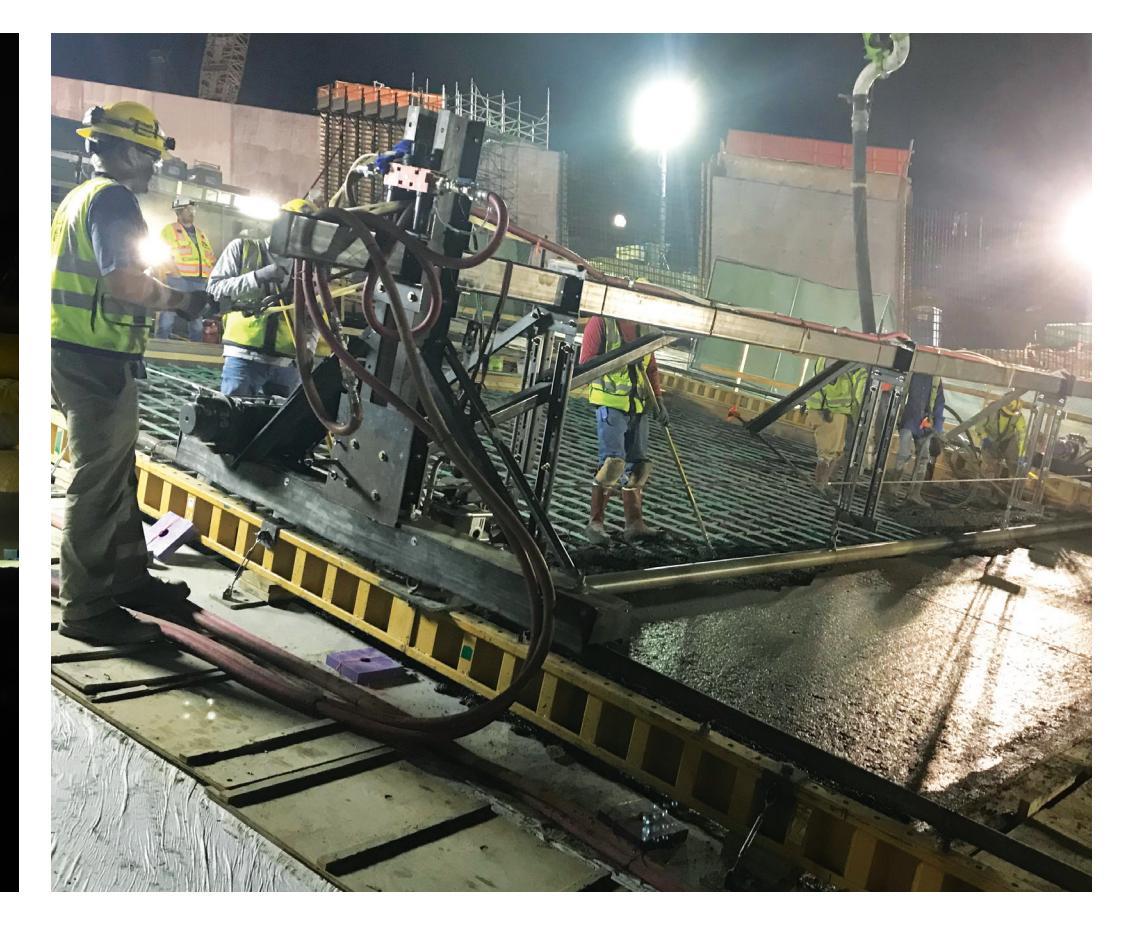
INVENTIVE

On the steeply sloping lower spillway chute (middle), crews struggled to operate screeds by hand. Enter the "Franken-screed" (right), a device that pulls the screed mechanically up the 25% slope.
